Fish Passage Engineering Research

Fish Passage Engineering Research Project Summary of Findings

DRISI Agreement No. 65A0711

Upp Creek, MEN 101 – PM48.18 (Willits, CA)

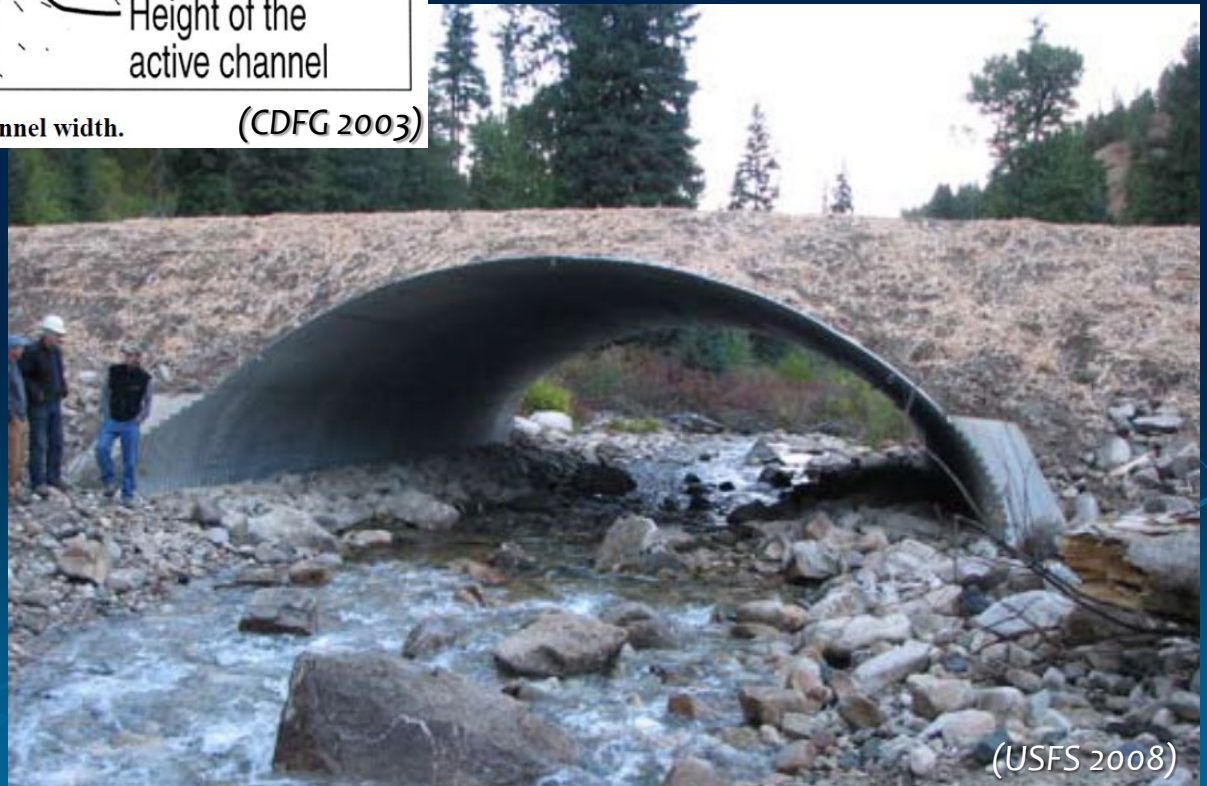
Crossing structures with spans that exceed the bankfull channel width

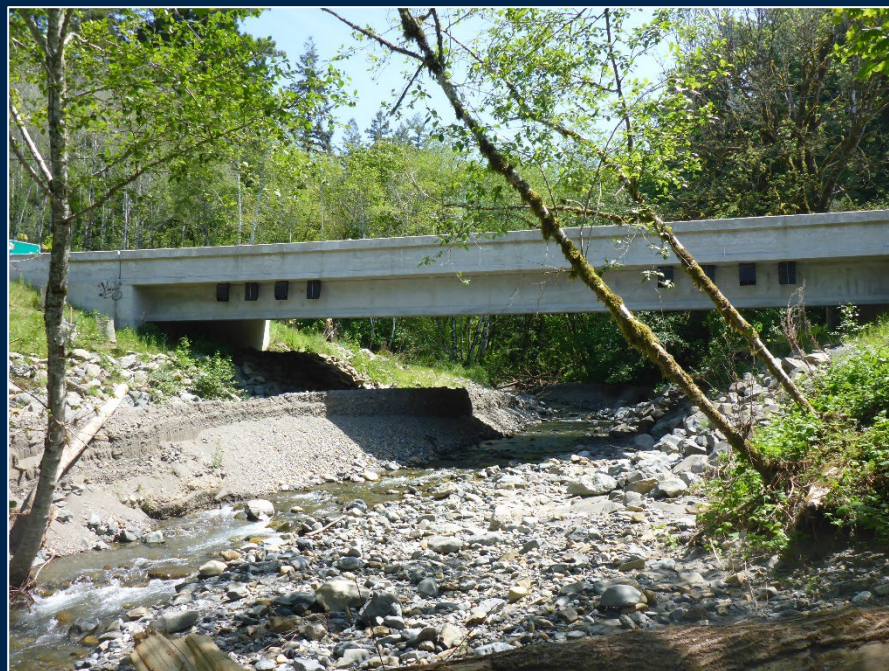
Nearly all crossings replaced with full-span bridges performed well

Little Mill Creek Full-Span Bridge

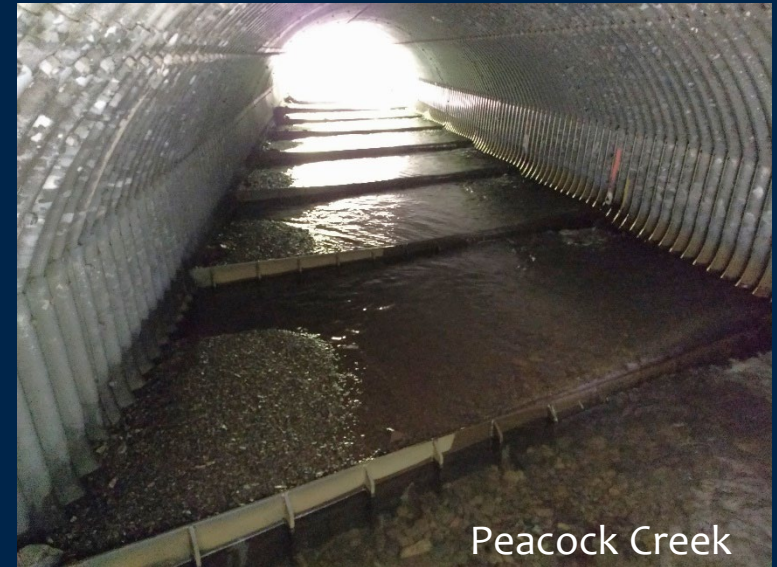
- 4 study sites retrofitted with fishways/baffles
- All appeared to be constructed and functioning as intended, meeting passage criteria
- All retrofits were in crossing structures with adequate width

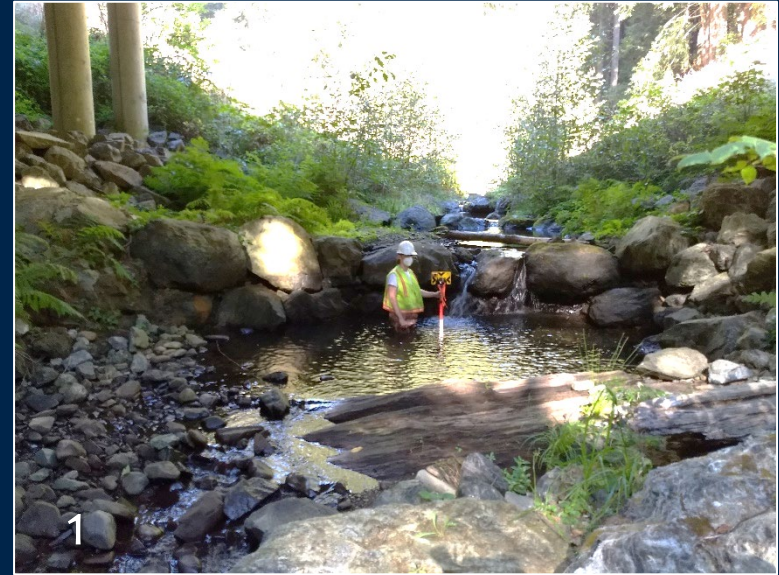
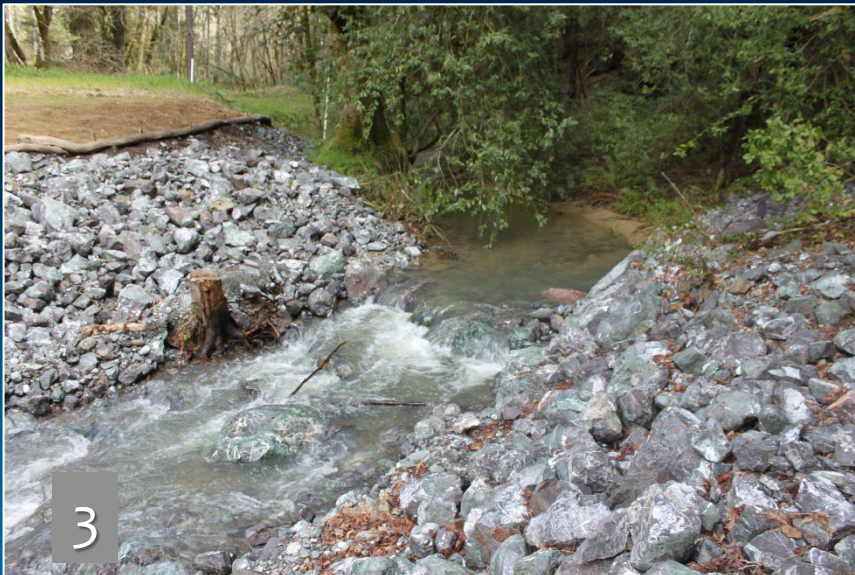
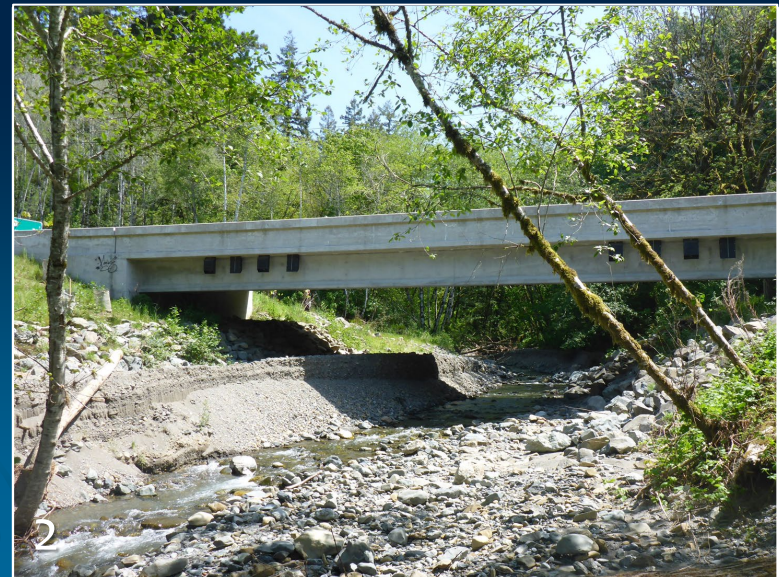
1. Post-project channel incision/bed lowering
2. Influence of adjacent river on channel dynamics
3. Local aggradation deposited upstream of pre-project crossing

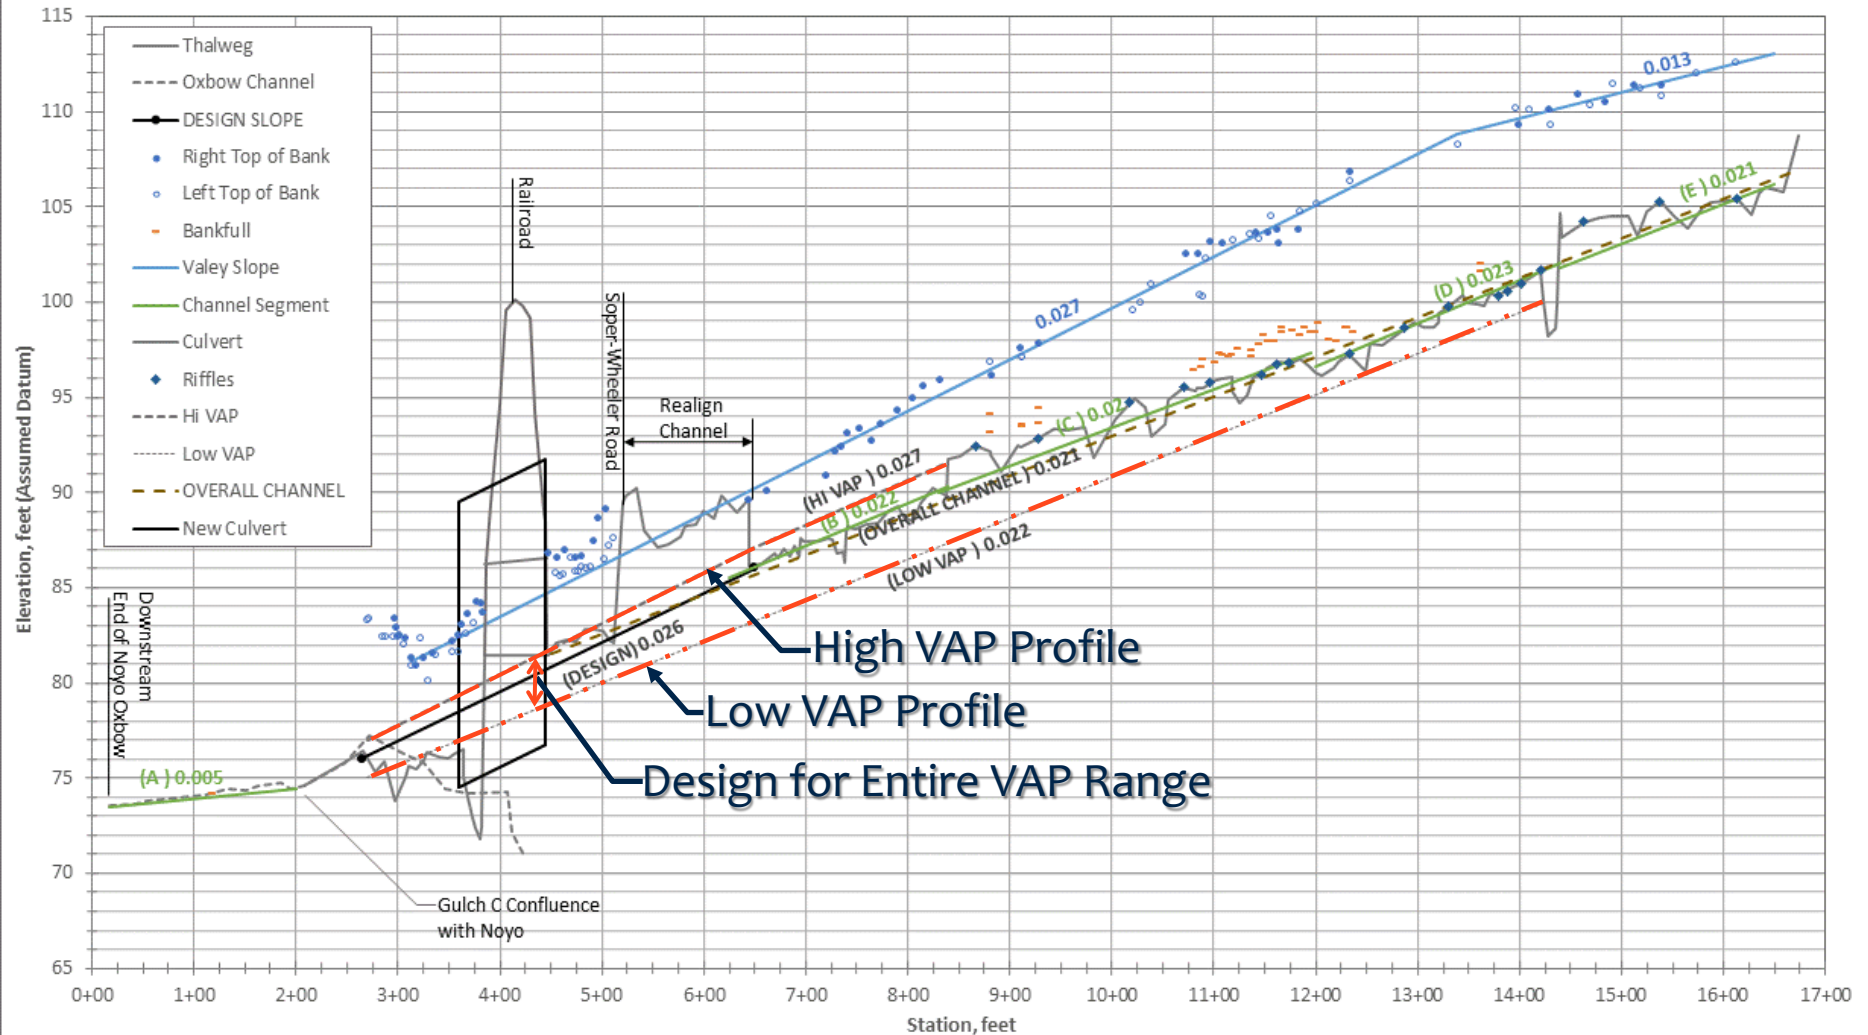
Gulch C Longitudinal Profile and Design Profiles

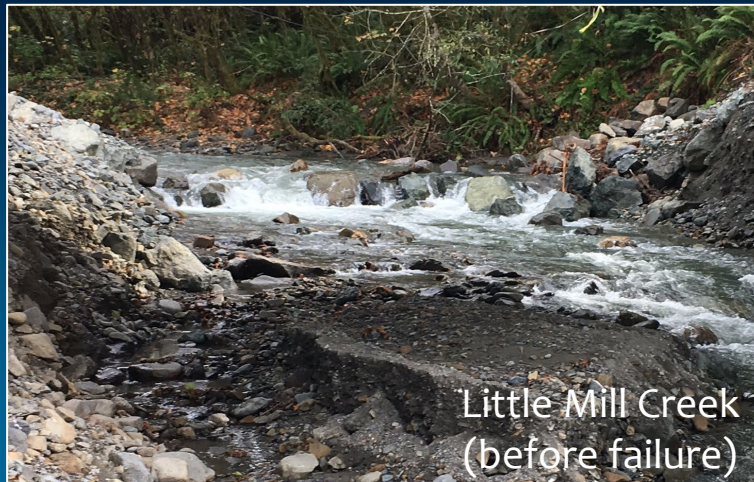
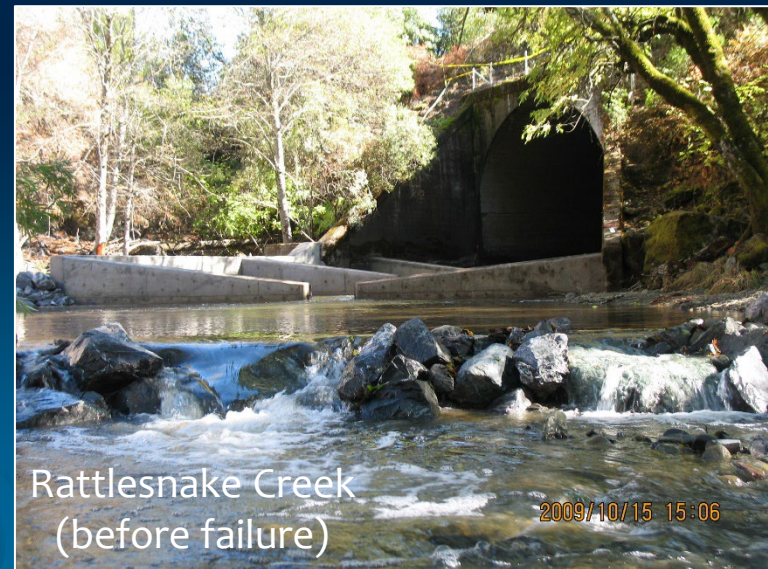
1. Rock weirs only type of rock-based grade control used at study sites
2. One or more rock weirs failed at 7 of 8 study sites
3. Various causes of failure from both design and construction
4. Constructed drop heights over rock weirs varied substantially from design

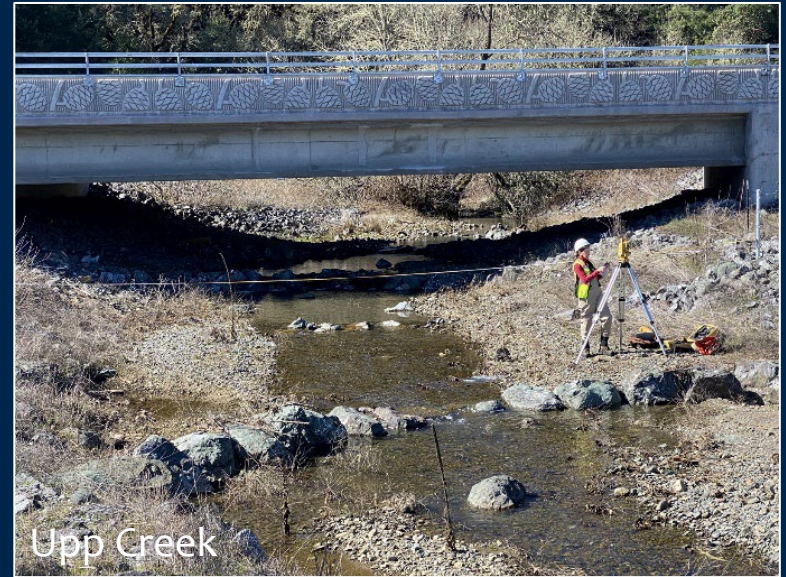
Upp Creek

Channel width through crossing excessively wide compared to adjacent natural channel

- Lack of streambanks to create confinement
- Produces shallower flow depths than in adjacent natural channel
- Likely creating low-flow barriers to fish movement

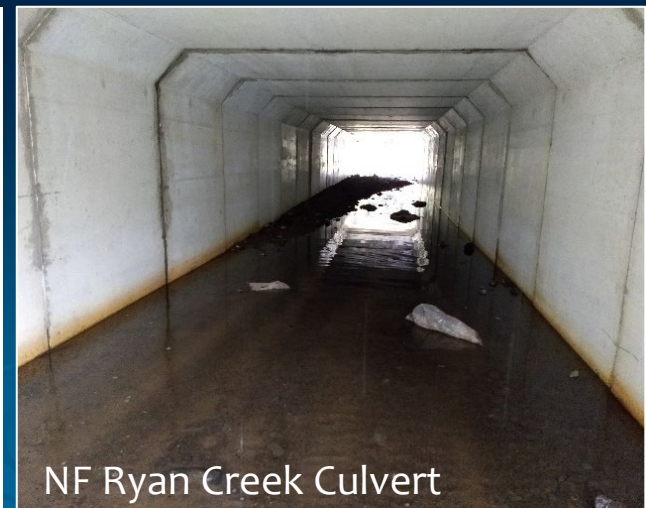
- Culverts narrower than upstream bankfull channel
- Streambed profile flattened through embedded culverts
- No bed features (pools/riffles) resulting in shallow flow conditions
- Lack the “profile controls” that influences natural channel grade

NF Ryan Creek Culvert

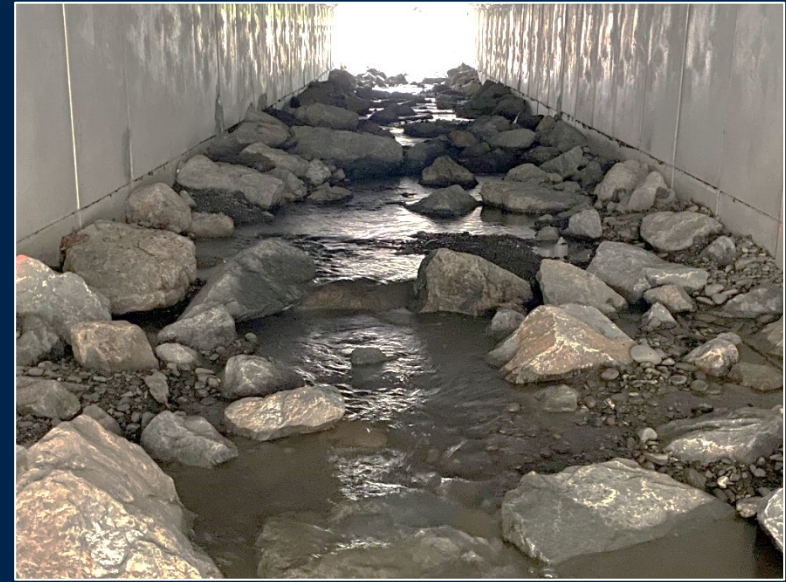
Example of a “roughened channel” grade control in a box culvert

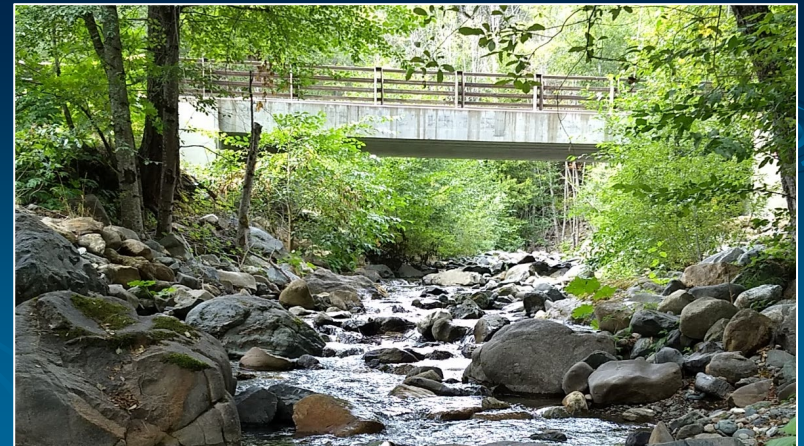
Fort Goff Bridge Channel
