Fish Creek Fish Passage Project

California Department of Transportation – District 1

Fish Creek Fish Passage

The project is located in Humboldt County on State Route 254 at post mile 4.18 along the Avenue of the Giants in Humboldt Redwoods State Park.

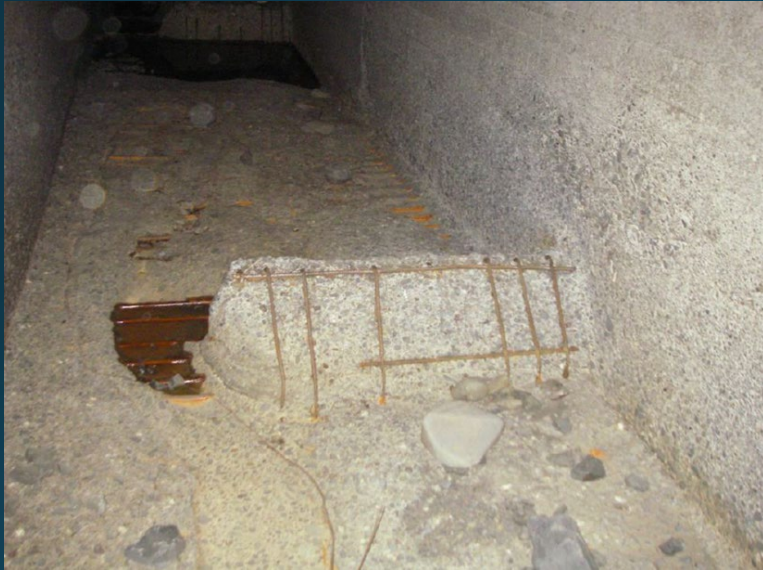
Culvert As-Built

1917: A 6' x 6' x 57'9" long RCB culvert was constructed.

1930: The culvert was extended at the inlet and a headwall and wingwalls were added.

1980: Invert paving and 8 concrete baffles were added for fish passage to the RCB culvert.

The culvert was considered a partial barrier to adult salmonids and a complete barrier to resident and juvenile salmonids. According to the Lang Report (2005), the culvert created a depth and velocity barrier to resident adults and juveniles and was only passable by anadromous adults during 15% of flows.

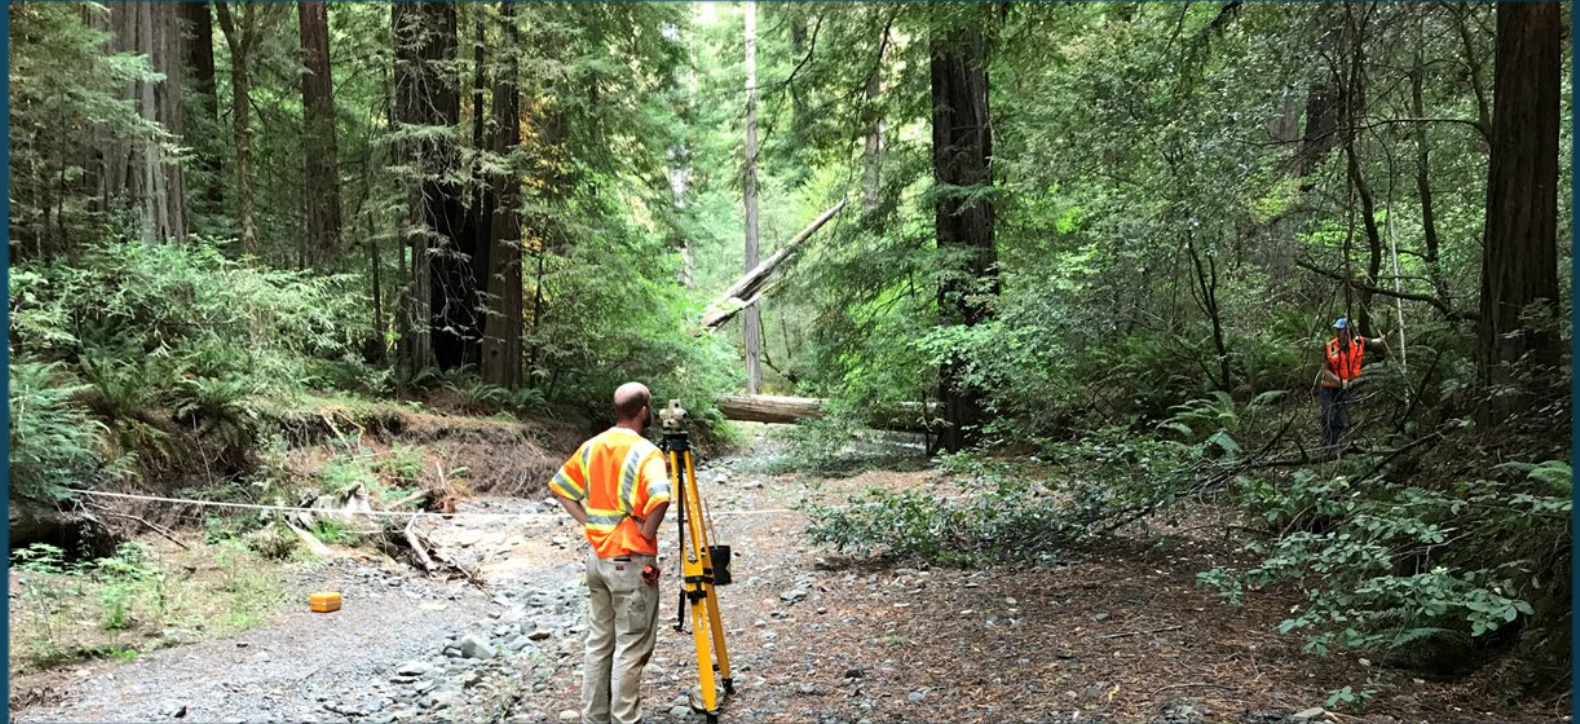
Hydraulic Engineering Data Collection

Lidar, cross section surveys with an auto level, pebble counts and grab samples, and reference reach measurements

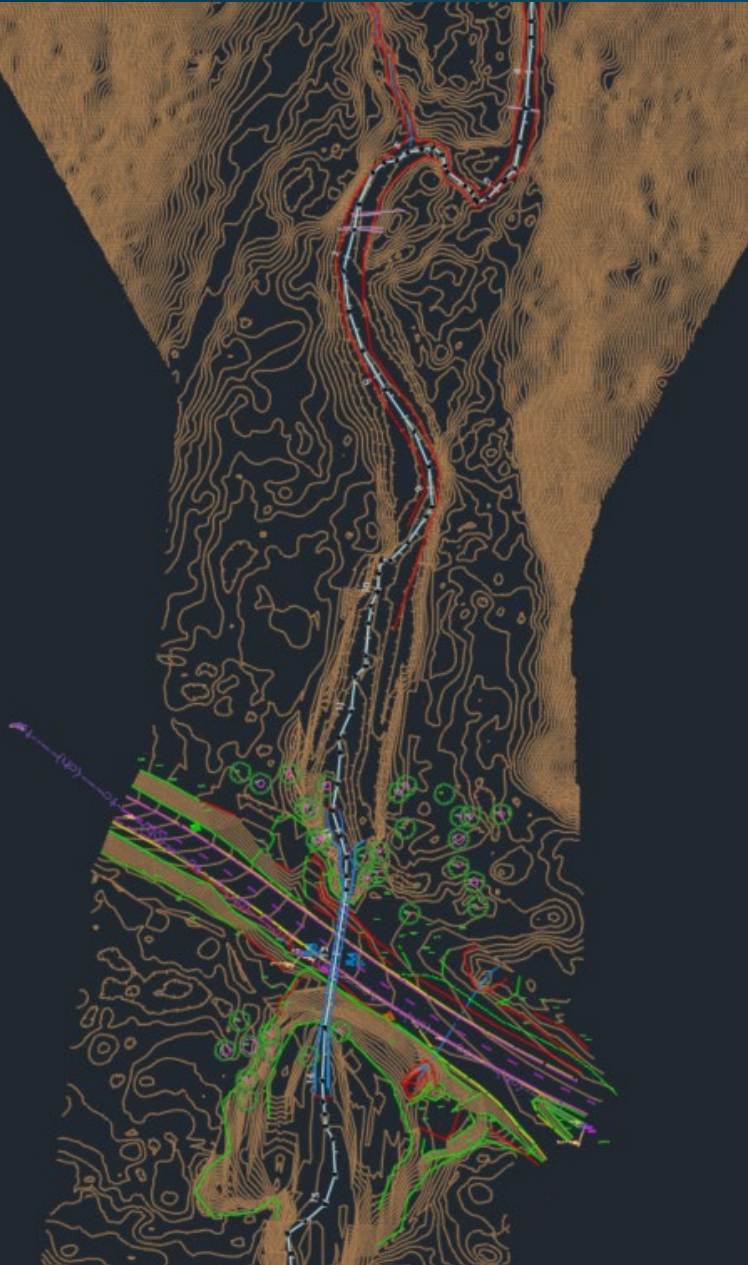
Large wood revetment to protect redwood roots from potential scour

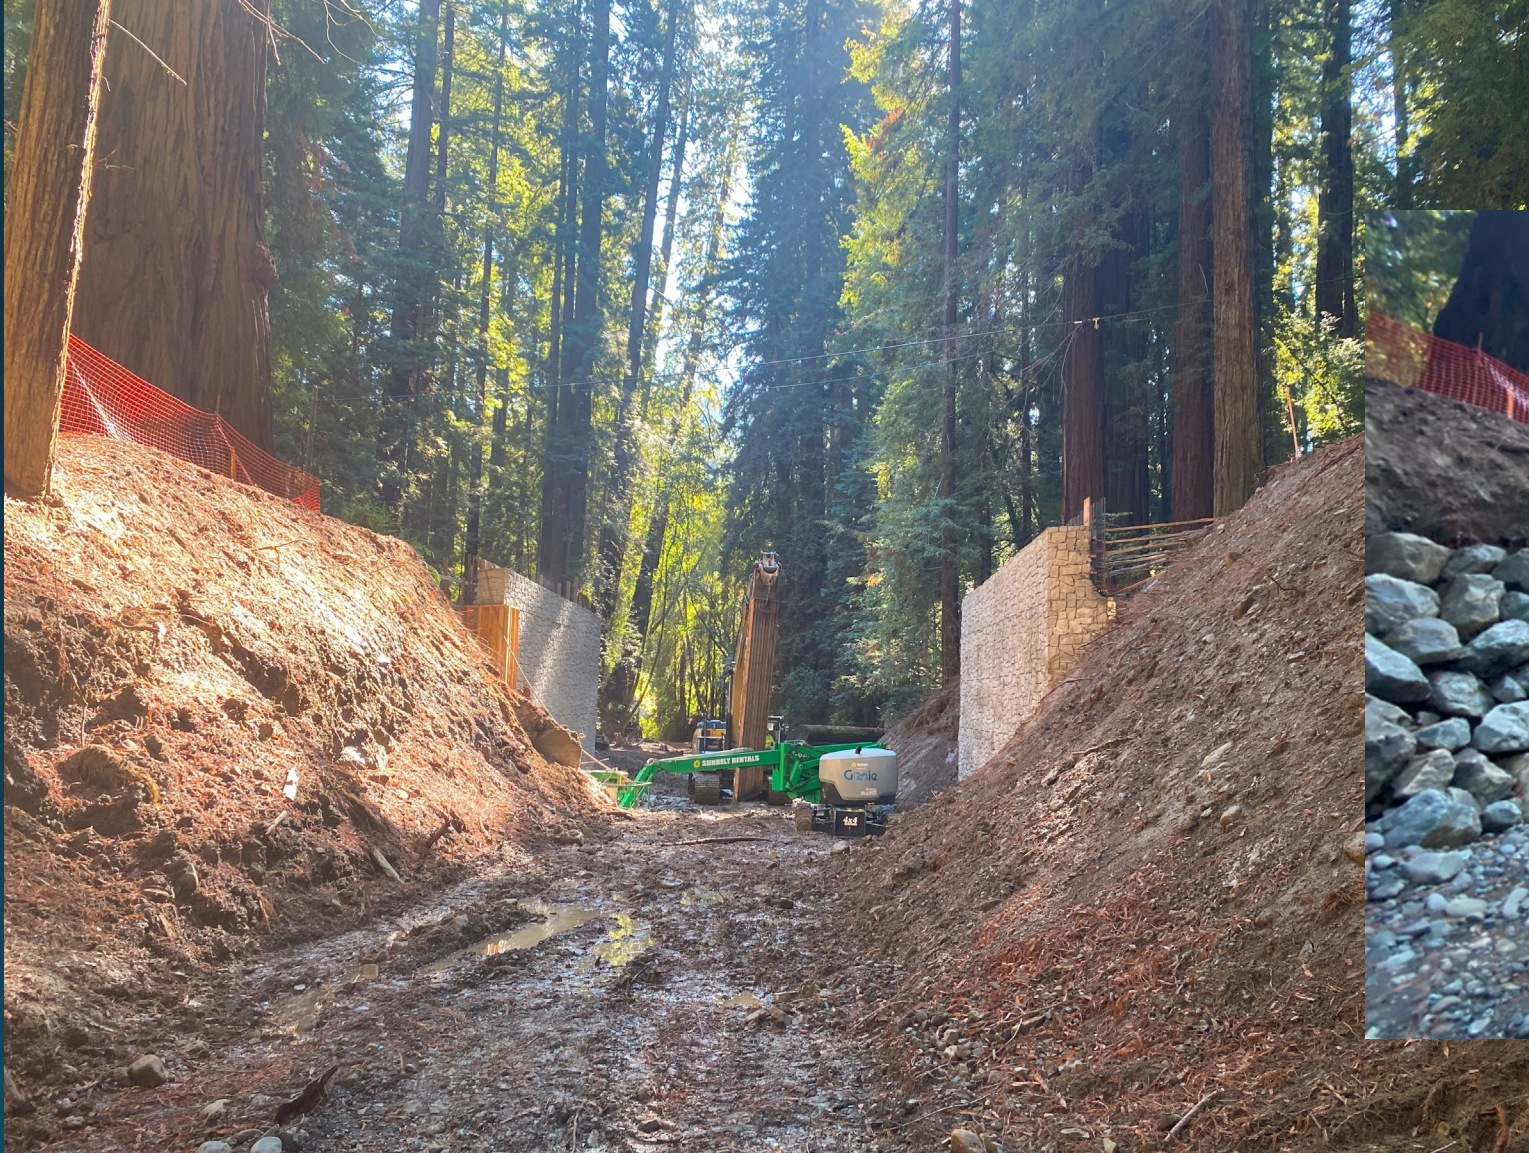
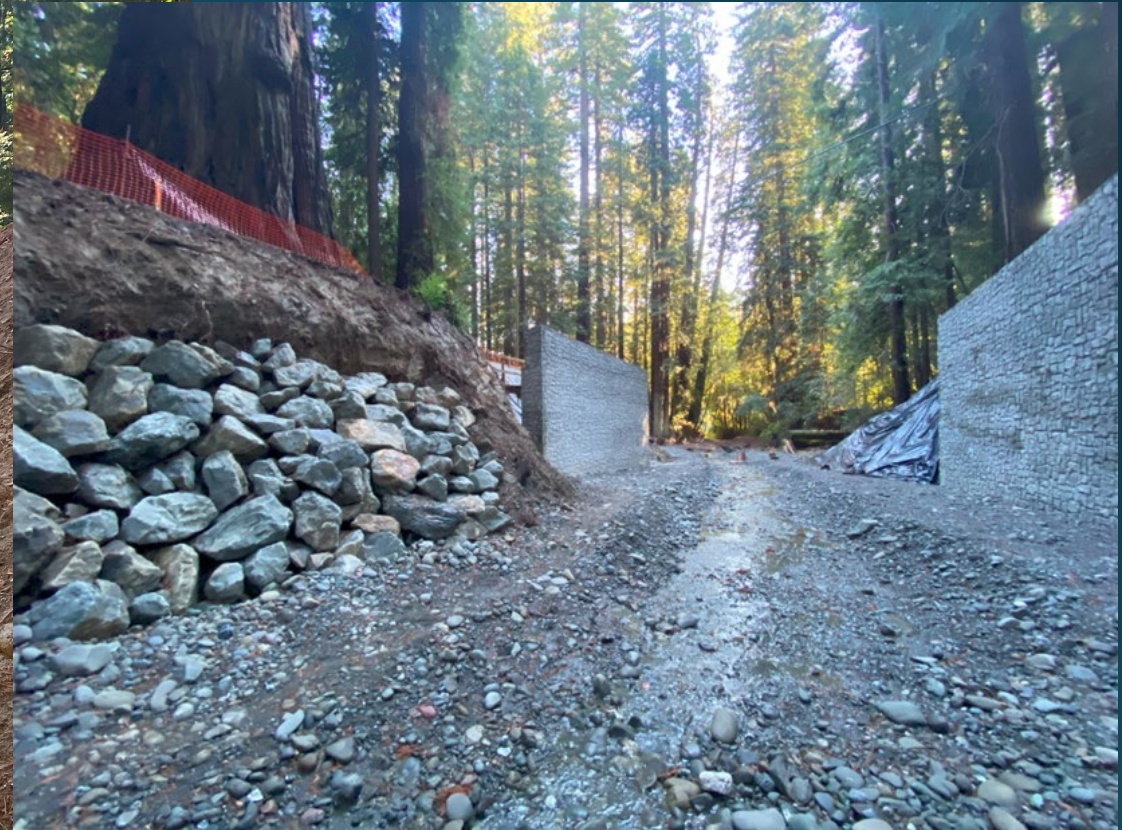
Unconsolidated fill
discovered during
construction of abutments

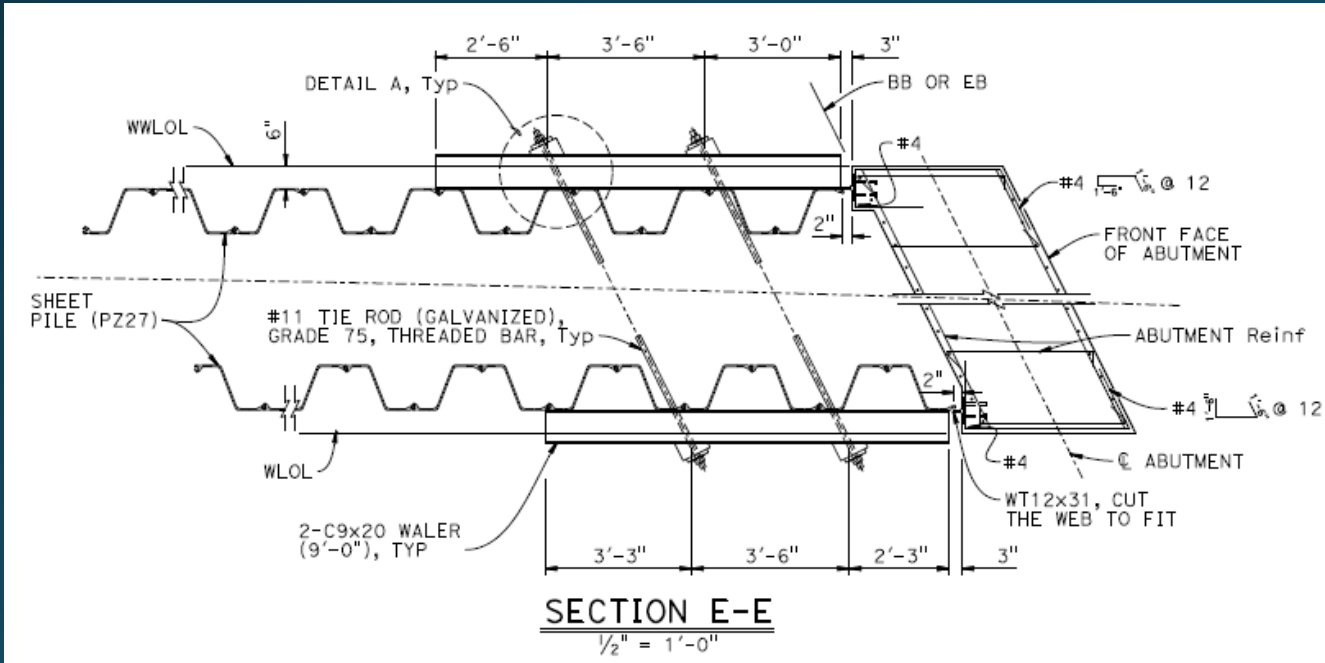
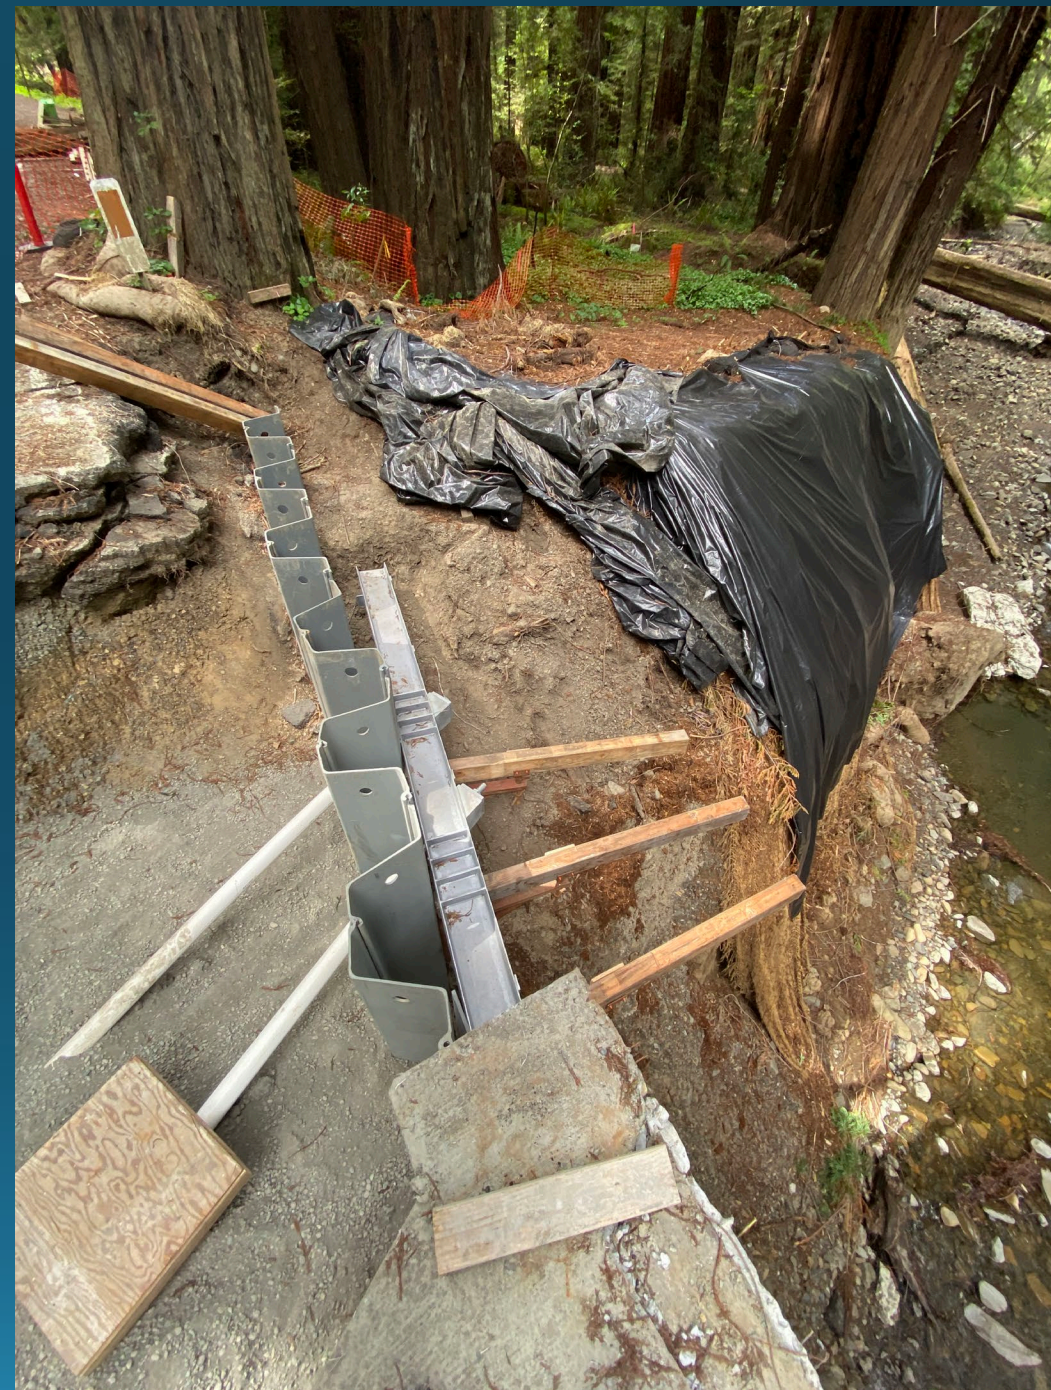
Re-design during construction

The proposed concrete wingwall could not be constructed due to excavation concerns and redwood roots.

Sheet pile connection to abutment required a re-design

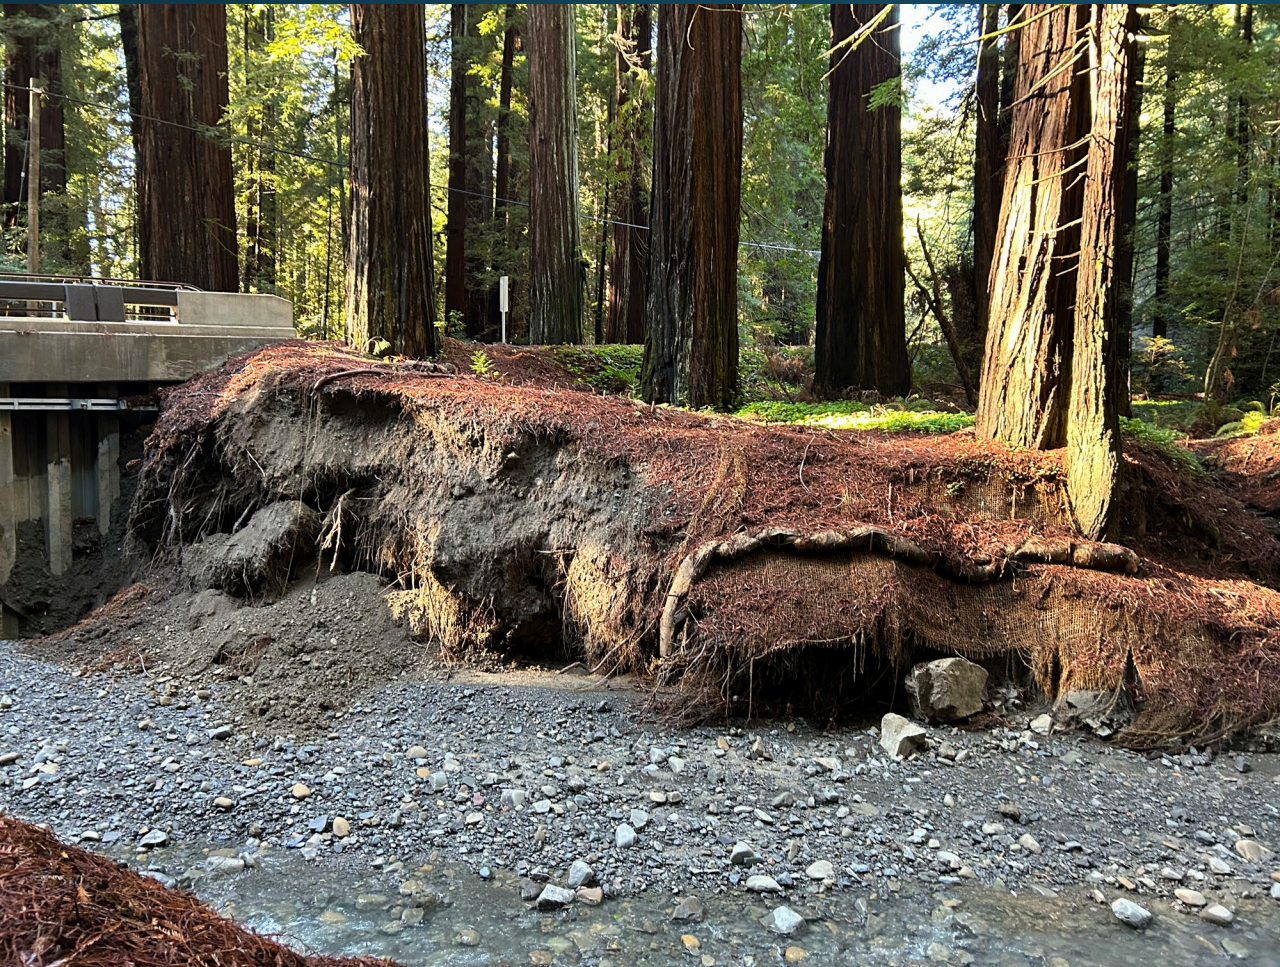
12/3/24

Restoration can be messy and eventually we will reach *equilibrium*
